DEPARTMENT OF TRANSPORTATION**DIVISION OF ENGINEERING SERVICES**

Contract #: 04-0120F4Cty: SF/ALA Rte: 80 PM: 13.2/13.9File #: 1.28**WELDING INSPECTION REPORT****Resident Engineer:** Casey, William**Address:** 333 Burma Road**City:** Oakland, CA 94607**Report No:** WIR-028987**Date Inspected:** 15-Jan-2013**Project Name:** SAS Superstructure**OSM Arrival Time:** 700**Prime Contractor:** American Bridge/Fluor Enterprises, a JV**OSM Departure Time:** 1730**Contractor:** American Bridge/Fluor Enterprises, a JV**Location:** Job Site**CWI Name:** William Sherwood**CWI Present:** Yes No**Inspected CWI report:** Yes No N/A**Rod Oven in Use:** Yes No N/A**Electrode to specification:** Yes No N/A**Weld Procedures Followed:** Yes No N/A**Qualified Welders:** Yes No N/A**Verified Joint Fit-up:** Yes No N/A**Approved Drawings:** Yes No N/A**Approved WPS:** Yes No N/A**Delayed / Cancelled:** Yes No N/A**Bridge No:** 34-0006**Component:** SAS Tower**Summary of Items Observed:**

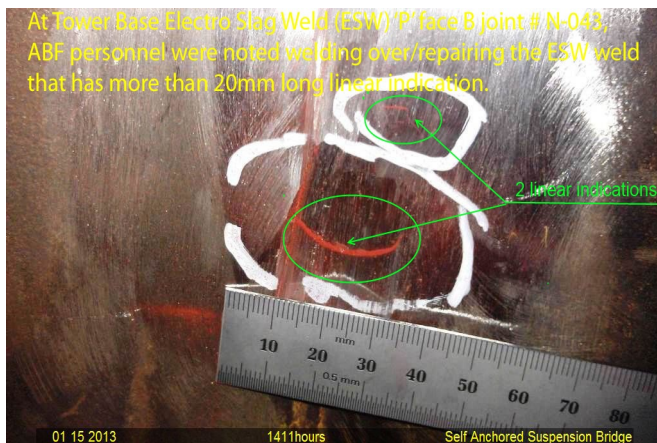
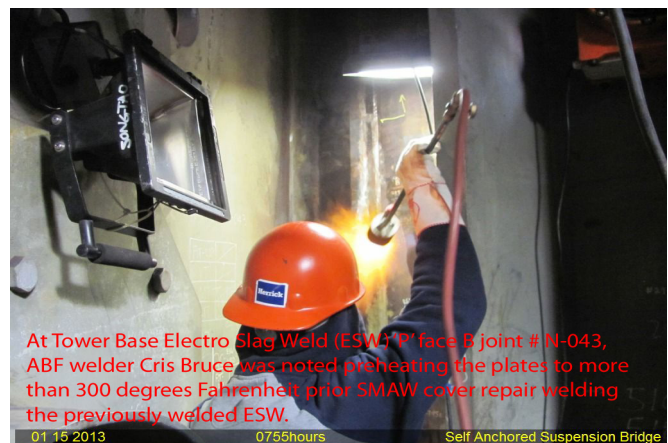
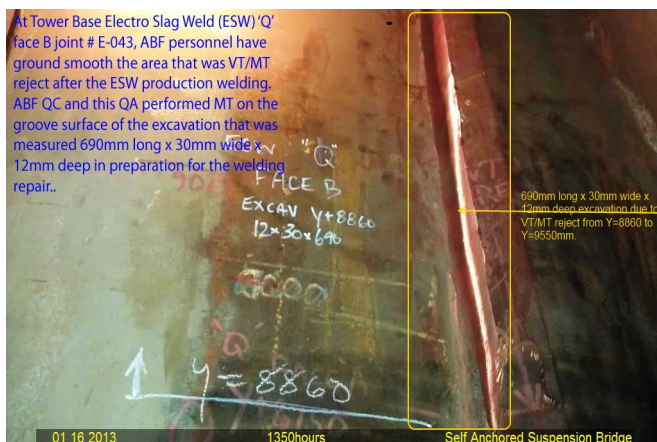
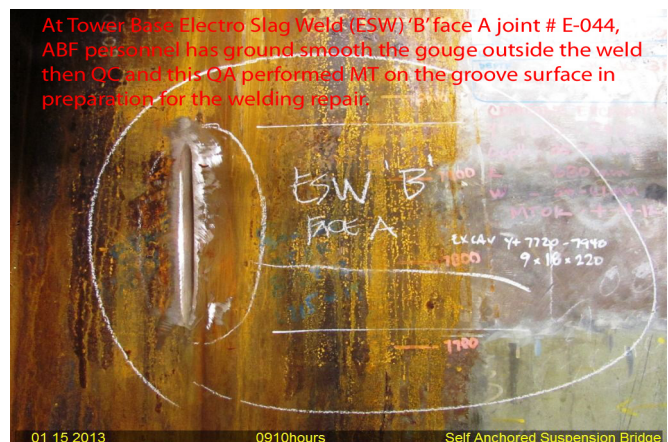
At Tower Base Electro Slag Weld (ESW) 'Q' weld joint #E-043 face B, ABF welder Cris Bruce was observed perform 3G welding repair on the weld cover on previously welded ESW from Y=6000mm to Y=8000mm due to VT/MT reject. The welder was noted utilizing Shielded Metal Arc Welding (SMAW) with 1/8" diameter E7018H4R electrode implementing ABF-WPS-D15-1000 Repair. The surface of the areas that were welded was ground smooth and was having depth of less than 5mm. These areas were also tested by ABF QC William Sherwood using Magnetic Particle Testing (MT) with no relevant indications noted. This QA also performed the same test and noted same result. Prior welding, ABF personnel have preheated the repair area to more than 300°F using propylene gas torch. During the shift, the ABF QC William Sherwood was noted monitoring the welding parameters and workmanship of the repairs being welded.

After the weld cover repair completion of ESW 'Q' from face B, the same welder has moved to ESW 'P' face B and performed the same weld cover repair due to VT/MT reject. The welder was observed performing repair from Y=6000mm to Y=9870mm. The welder was noted utilizing Shielded Metal Arc Welding (SMAW) with 1/8" diameter E7018H4R electrode implementing ABF-WPS-D15-1000 Repair Rev. 3. The surface of the areas that were welded was ground smooth and was having depth of less than 5mm. These areas were also tested by ABF QC William Sherwood using Magnetic Particle Testing (MT) with no relevant indications noted. This QA also performed the same test and noted same result. Prior welding, ABF personnel have preheated the repair area to

During the MT Inspection of the ground surface of ESW 'P' face B at Y=6075mm, ABF QC Steve Jensen has found two linear indications that one was more than 20mm and the other was around 8mm long. Upon further investigation from QC, they found out that the area just mentioned that has the linear indication is a bolt hole that has been plugged during the Electro Slag Welding process of the same butt joint 'P'. One of the QC thought that since ABF will be re-drilling the same hole when they install the Tower skirt, it was okay to weld over the two linear indications. This QA thought that that was not the right thing to do so QA has informed QC to ask for instruction from Engineer which QC never did. Due to this infraction of welding over linear indication, an Incident Report was generated.
